# Shayrat Airbase – Update on US Missile Attack 7th Apr 2017

Analysis by Tim Ripley

The Following presentations is drawn from Russian MOD and Media footage filmed on 7<sup>th</sup> April 2017, as well as US DoD satellite imagery

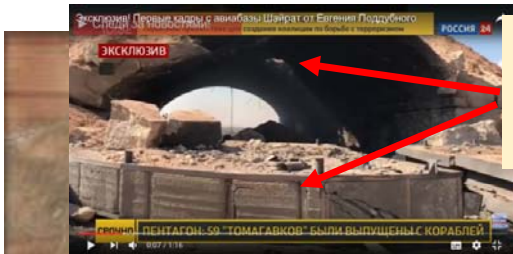
HAS with blast doors blown off after roof penetrated

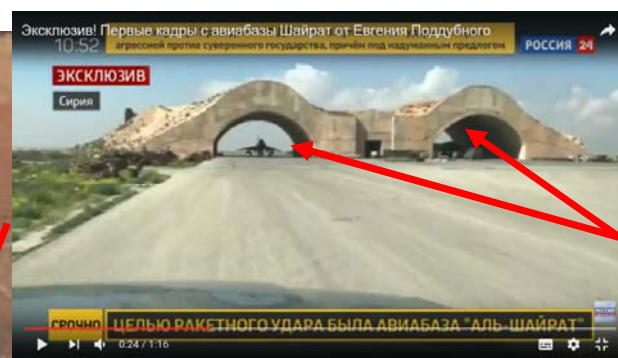
HAS with intact Su-22 bombers inside

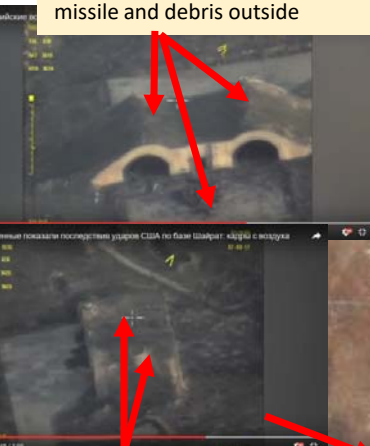
Pair HAS with roof penetrated by missile and debris outside

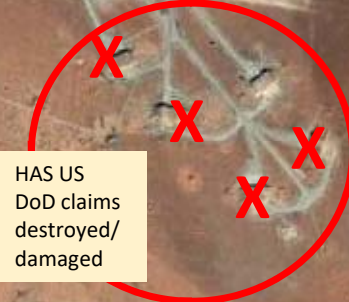
Remains of 2 x aircraft inside, including 1 x Su-22, unidentified HAS

It is not possible to assess damage inside most of shelters or if aircraft were hit. One picture shows the burnt out remains of 3 aircraft inside a pair of shelters

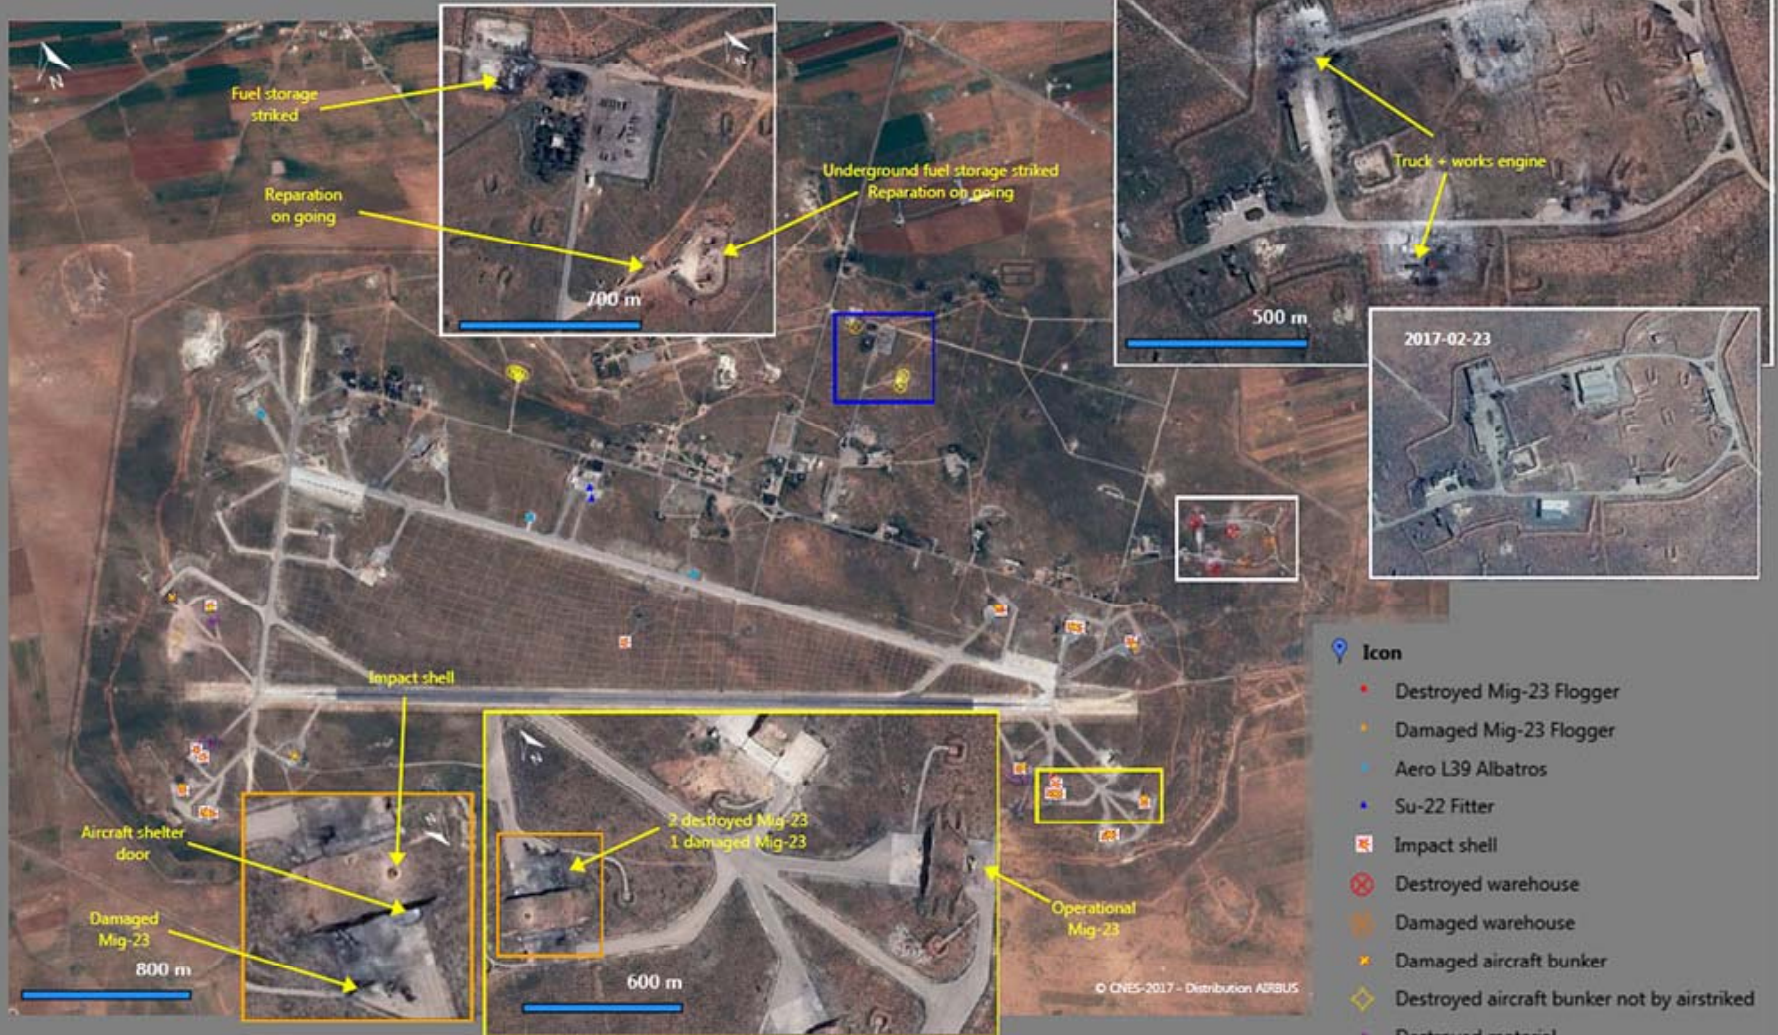
Al Sharyat Airbase - Syria  
 Pleiades: 2017-04-09  
 RP: 34° 29' 24" N / 036° 54' 29" E

Analysis made from Pleiades Image acquired on April 8th and 9th, 2017 highlighted the US Battle Damage Assessment on the night of April 7th. The aeronautical infrastructures were not damaged and still fully operational. Only the fuel depots, the depot in the East and some aircraft shelters were struck. At least 3 Mig-23 have been destroyed or damaged. There is nothing to confirm that the damaged shelters weren't home aircraft. On April 9th 3 Albatros, 1 Mig-23 and 2 Su-22 still seemed operational.
